**LTPP Seasonal Monitoring
Program**

Site Monitoring Suspension

Section 364018

Oneonta, New York

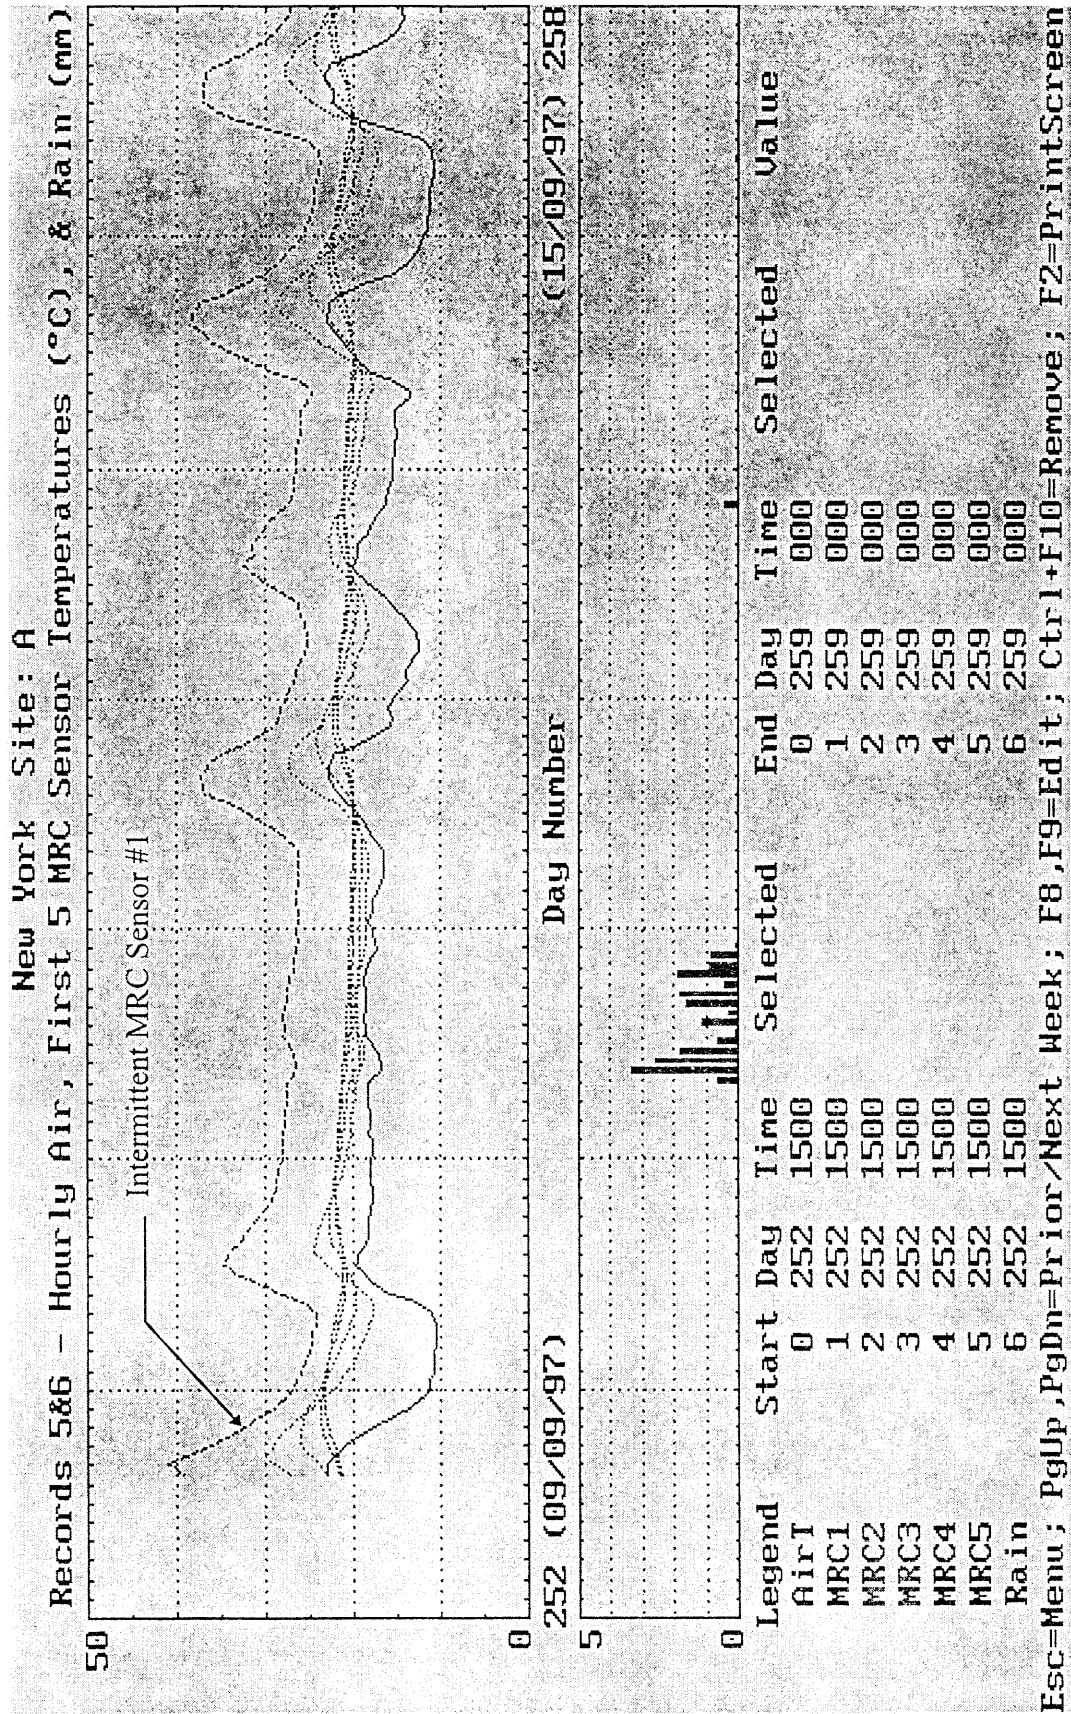
Figure 2: Sample of Erroneous Readings from MRC Sensor #1

At the time of suspension, MRC #1 sensor was not functioning. This sensor was not functioning at the time Round 2 data collection activities began in September 1996. Also, TDR sensors 2, 5 & 7 are not functioning. At the time of re-commission (September 19, 1996), these sensors were producing irregular traces. At that time, we speculated that they might have broken at the beginning of the probe or were filled with water. Figure 2 shows the daily temperature trends during a sample period indicating that the MRC #1 sensor was malfunctioning. Figure 3 shows the second set of Mobile Data collected on October 14, 1997. Other than the above, there were no unresolved problems with any other sensors. The plots from ONSFIELD, MOBFIELD and SMPCHECK follow expected trends and produced expected values.

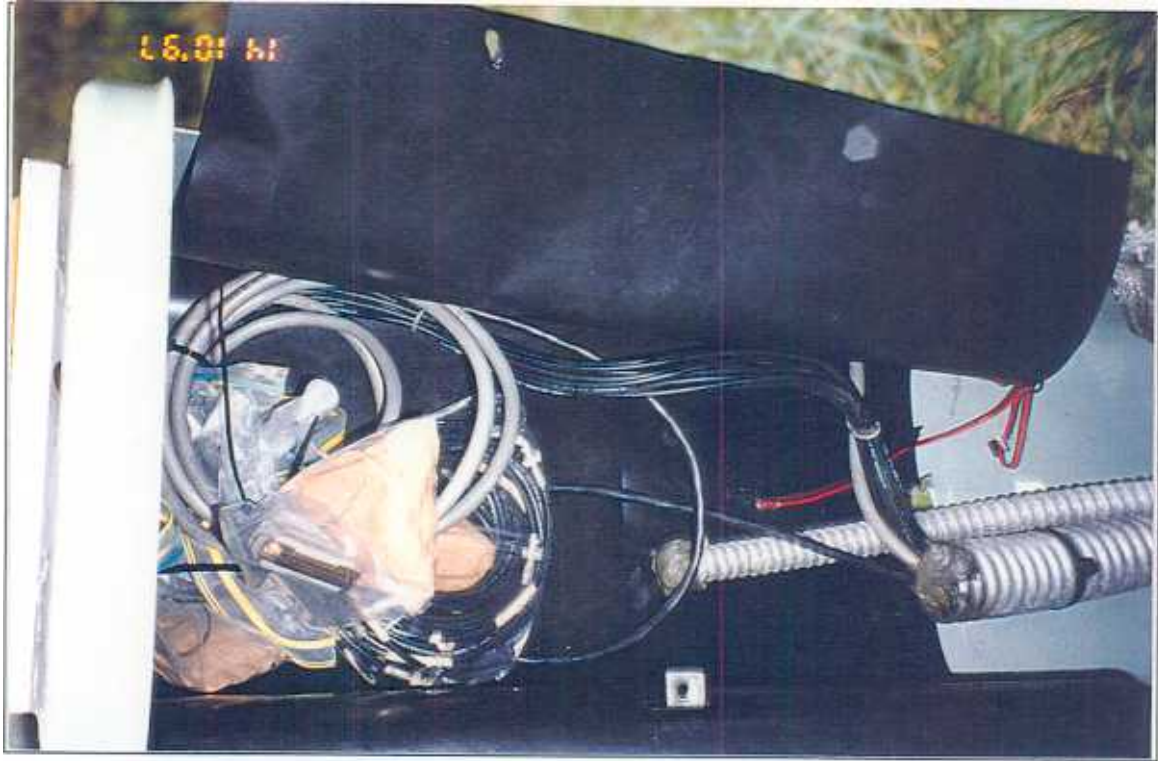
Inside Equipment Cabinet, Seasonal Site 364018 - Oct. 1997, after Suspension Activities

The solar panel was disconnected. After all wires from the control panel were disconnected, the panel was detached from the equipment cabinet along with the CR10 datalogger, terminal strip and battery pack. The TDR cables, resistivity cable and MRC lead wires were sprayed with an anti-corrosion compound and sealed with desiccant packs in air tight bags. All cables were hung up high inside the equipment cabinet. After the last piezometer reading was recorded, the pipe was cleaned and sealed with grease. The access cover and seat were cleaned and lubricated before being covered and brought up to grade with native soil.

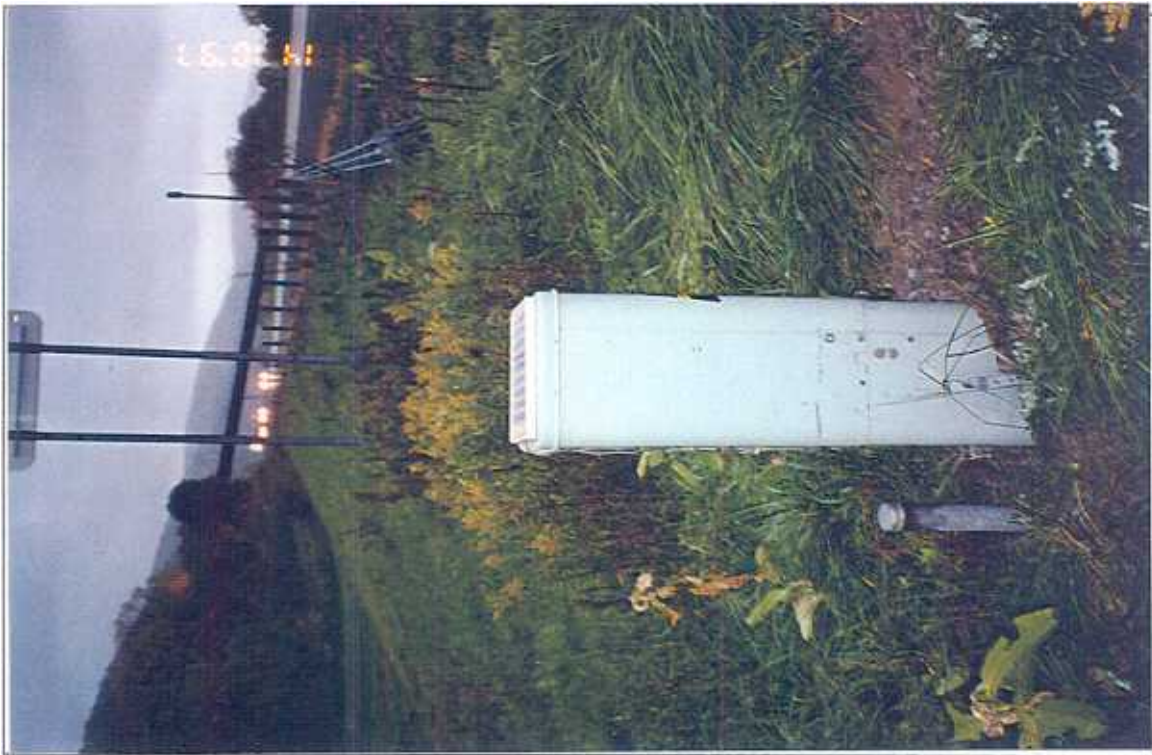
Equipment Cabinet, Seasonal Site 364018 - Oct. 1997, after Suspension Activities

All the necessary suspension activities were completed on October 14, 1997. The dismantled equipment was removed from the site. The suspended site contains all the underground instrumentation and equipment, and an equipment cabinet with all the cables in it. The equipment cabinet was locked before leaving the site. The site was cleaned and left in a condition such that the instrumentation could be easily accessed when the need arises.
